# Enhancing Cable System Integrity: Root Cause Analysis of Joint Failures

Root cause analysis can help in preventing future failures and improving maintenance and procurement practices, which increases reliability of the cable network, says **Dr. Nitin Shingne, Head of Advanced Materials, Electrical Research and Development Association (ERDA), Vadodara.**

## Failure in 33 kV Cables Joint

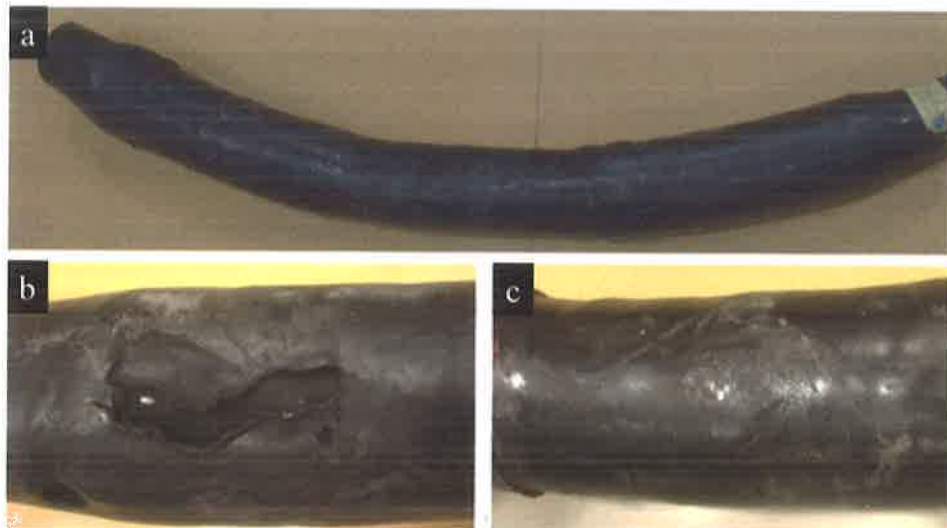
Figure 1 shows 33 kV failed cable joint. The joint failed after a service life of less than one year. The failure was observed in the form of puncture and overheating marks on the outer sheath of joint.

**Figure 1: a) Failed 33 kV cable joint, b) Puncture on the joint, c) Outer sheath showing indications of overheating.**

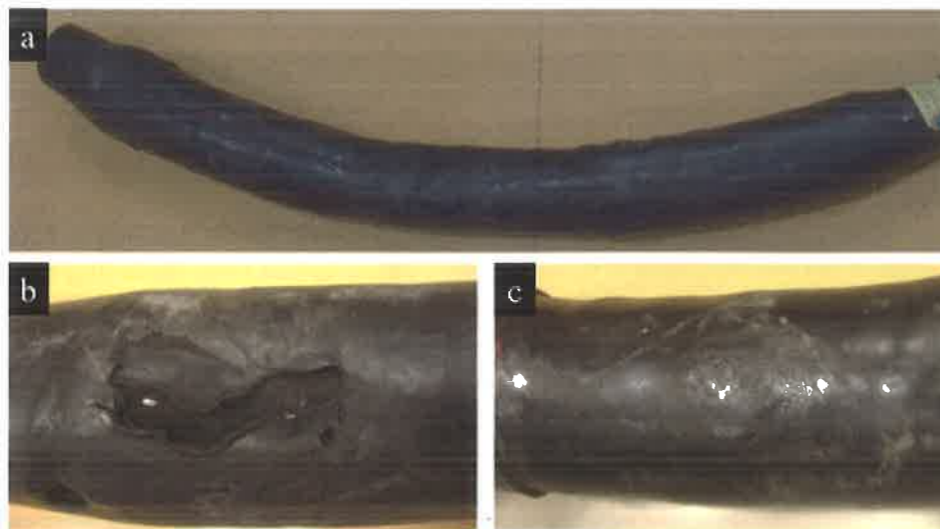
Figure 1 shows 33 kV failed cable joint. The joint failed after a service life of less than one year. The failure was observed in the form of puncture and overheating marks on the outer sheath of joint.

Figure 1: a) Failed 33 kV cable joint, b) Puncture on the joint, c) Outer sheath showing indications of overheating.

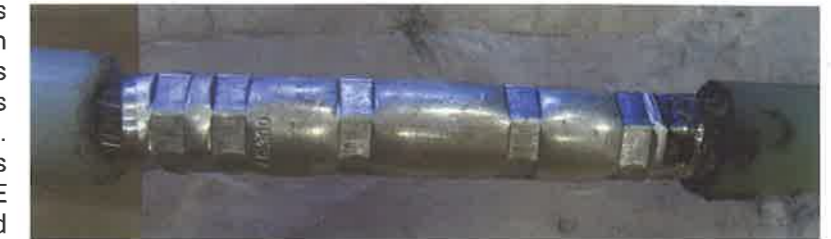
When the joint was opened for post-mortem analysis, the problem was observed at the conductor joint as shown in Figure 2. The conductor connector

or lug was improperly placed and bend near the XLPE insulation on one side; on the other side, there was sufficient gap between the insulation and lug. The XLPE insulation was improperly cut, and blade marks were still visible on the insulation. Improper crimping and sharp edges of the lug were touching the XLPE insulation, which led to localised heating and progressive degradation of XLPE insulation, resulting in failure of the cable joint.

Figure 2: Cable conductor joint with visible melting of aluminium lug on and burned XLPE insulation.

- Use of skilled and certified cable jointers for cable termination and jointing.
- Cable joint and terminations to be tested in laboratory as per IS 13573 to verify their performance and workmanship.
- Videography of the cable jointing process, including joint identification, is essential for identifying errors and implementing future corrective actions.
- Making sure earth connections are proper, and earth resistance is minimum.

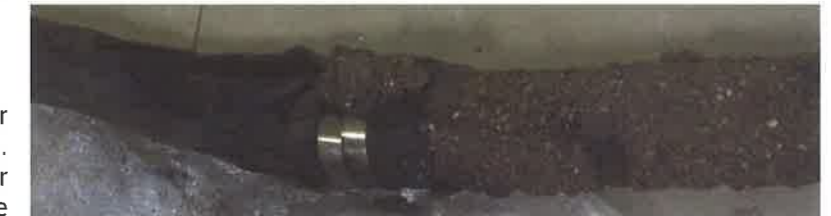
Figure 3: Failed part of the 66-kV cable joint.

A 66-kV cable joint failed after a service life of seven months. The failed cable joint was used for jointing 66 kV XLPE insulated single core cable that was laid underground. The cable had corrugated aluminium sheath covered by bitumen compound for protection against water and corrosion. The outer sheath was made up of HDPE to protect all inner components from the environment. The total length of failed joint received at ERDA was 187 cm; the failure was observed at one end of the joint as shown in Figure 3. At the failure end, the outer sheath was covered with sand due to melting of the sheath. The XLPE insulation was punctured in the joint, where the earth continuity copper wires from the joint were connected with cable aluminum sheath.

Post-mortem analysis of the cable joint showed a change in XLPE insulation colour to light yellow up to 5 cm from puncture location. This indicated prolonged overheating of the insulation before puncture. Dissection of the other end of the cable joint revealed improper jointing of the ground continuity wire connections on the aluminium sheath as shown in Figure 4. Before connecting the copper earth wires, the aluminium sheath was not properly cleaned, bitumen was still present, and black mastic tape was placed between the copper mesh and earthing wires. This resulted in localised contact resistance for the flow of sheath current, resulting in localised heating of the insulation when sheath current was high in the cable. This led to progressive degradation of XLPE and failure.

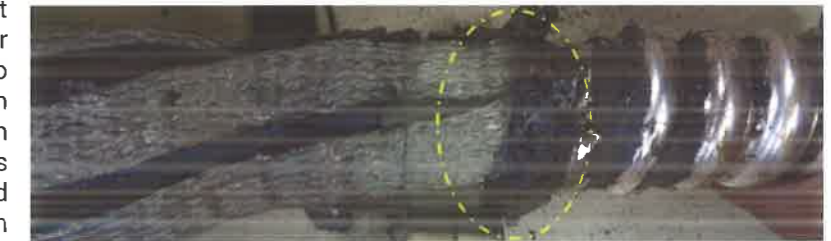
Figure 4: Connection of the earthing continuity wires with aluminium sheath.
