## ROOT CAUSE ANALYSIS OF TAP CHANGER FAILURE & ITS IMPACT ON POWER TRANSFORMER CONDITION

Anil S. KHOPKAR, Umesh N. SONI  
Electrical Research and Development Association  
ERDA Road, GIDC, Makarpura- Vadodara, India

#### 42.5 MVA 139/11 kV transformer tap changer failure.

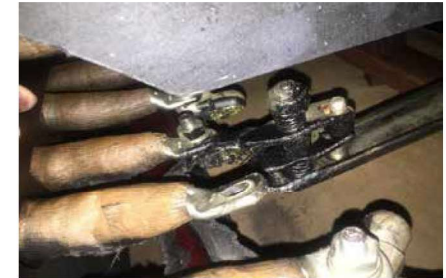
the site after draining the oil & internal visual inspection carried out. During visual inspection at site R-phase tap changer found melted & stuck at position no. 3. Black carbon deposition on the tap changer suggest that the contacts have been welded after melting due to high current passed through the tap changer contacts.

Figure1: Melted contacts resulting in a joint (weld) at one position of R-phase tap changer

On detailed visual inspection it was found that the coking & pitting observed on the transformer tap changer contacts. Due to this when high fault current passed through the tap changer contacts produces heating effect & contacts have been melted. As the decision need to take whether any other parts of transformer are affected by the failure of tap changer or not, further inspection of transformer was carried out. On further inspection of transformer it was found that crack was formed on the end press ring of the Y-phase winding highlighted in circle as per figure 2.

It was concluded that there is no further damage to transformer due to failure of tap changer. It was further recommended to do complete overhaul of the tap changer & replace the damaged end rings with damager paper insulation of LV winding. Further recommended to conduct the HV diagnostic test like capacitance/Tan delta before taking the transformer back in to service after rectification. It is also recommended to do periodic monitoring of the LA using third harmonic resistive current measurement, so any failure of the LA near to transformed can be avoided. Sequence of event suggest the flow heavy fault current through the R-phase for sufficient time to melt the R-phase tap changer contact, so it is recommended to review the protection relay coordination. Dynamic resistance measurement of tap changer can also reveals the defect related to tap changer due to coking & pitting. It was recommended to conduct the dynamic resistance of tap changer after rectification.

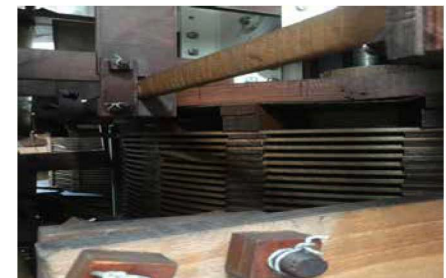
Figure 2: Crack observed on End press ring of Y-phase winding due to heavy pressure

However the crack formed on the end press ring was not due to failure of tap changer of R-phase but

it seems that end press ring has been cracked due to excessive pressure of clamp holding the end press ring. Further to this, paper insulation was found in damage condition as shown in figure.3.

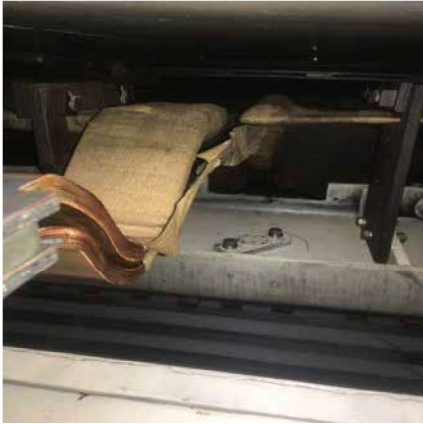
Figure 3 Damaged paper insulation on LV flexible connector

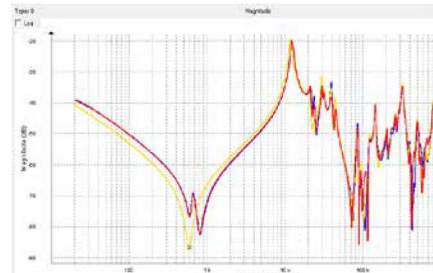
The SFRA measurement were taken & revealed that there is no damage to main winding occurs due to failure of the tap changer of R-phase.

Figure 4: SFRA traces of HV winding in LV open circuit condition at tap no.3

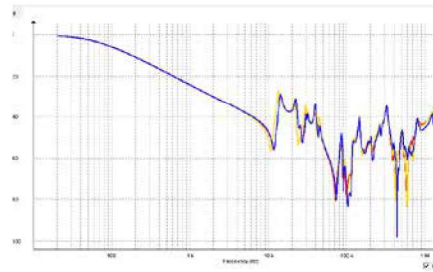
Figure 5: SFRA traces of HV winding in LV short circuit condition at tap no.3

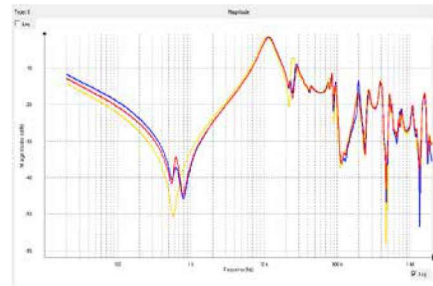
Figure 6: SFRA traces of LV winding

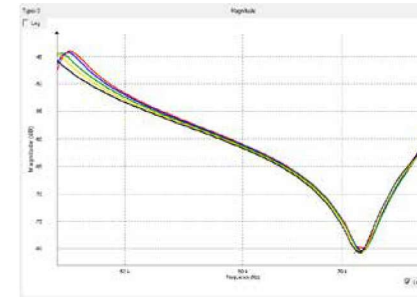
However it was noted that HV R-phase measurement at all taps are similar due to stuck tap changer & normal variation observed in Y-phase & B-phase as expected due change in tap changer position.

Figure 7: HV R-phase traces @70kHz at all tap position

The above figure shows that R-phase has stuck tap changer at tap position no.3. Overall SFRA traces reveal no mechanical damage to main winding, core & bushing.

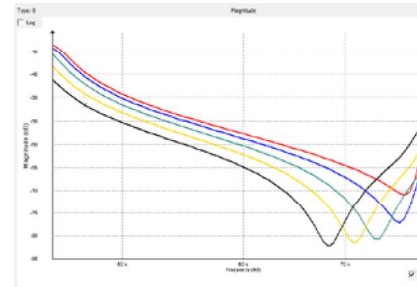
Figure 8: HV Y-phase traces @70 kHz at all tap position

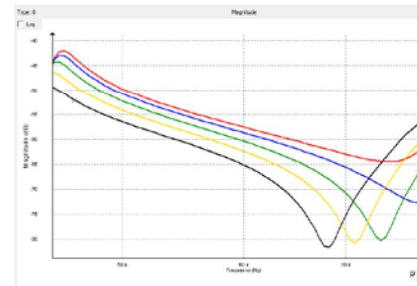
Figure 9: HV B-phase traces @70 kHz at all tap position

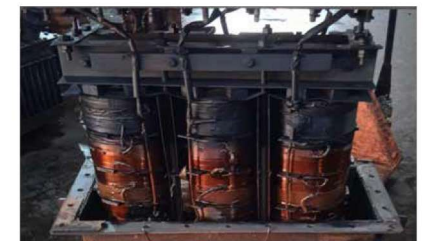
Fig 1: Low oil level

A low oil level in a distribution transformer leads to severe overheating and a reduction in
