ROOT CAUSES and REMEDIAL MEASURES FOR CABLE FAILURES

Sheetal Panchal, Shailesh Patel, Anil Khopkar
Electrical Research & Development Association, Vadodara
sheetal@erda.org

In this article, types of common and specific cable failures are discussed. Case studies on cable non-conformance and faults are described. An attempt has been made to identify the probable root causes and indicating pre-requisite recommendation(s) to mitigate the associated risks due to cable defect.

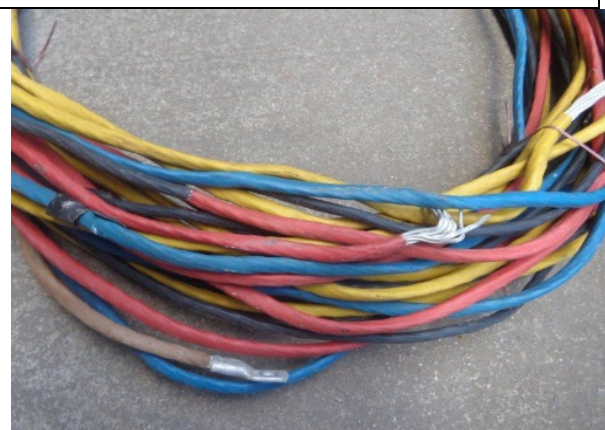
Figure 3. LT PVC cable

- Cable details : PVC cable – 4 Core 25 sq. mm LT PVC cable as per IS 1554

Type of failure : Insulation resistance failure

In this case study Insulation resistance test was carried out as per IS 10810 Part-43. During testing it was found that the insulation did not withstand 500 V DC for one minute. By visually inspection of insulation, it was observed that there was no crack or pin holes on the outer surface of the PVC insulation. The probable cause of failure may be due poor quality of material used for PVC insulation or moisture penetration. Also, the Ingredients used for colour of insulation may in excess quantity rather than the required quantity.

These problems can be overcome by selecting approved PVC material for insulation. The ratio of ingredients used for colour of the insulation shall be as per defined value.

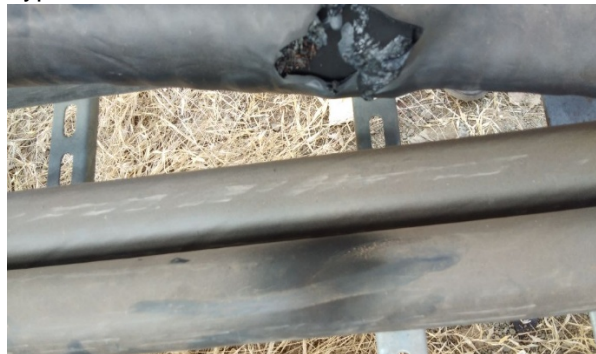
Figure 4. HV XLPE cable

Type of failure : Sheath failure

This case study impact on the poor workmanship at user end. During the laying of single core cable

many time outer sheath get damaged and because of that multi earthing of armour will be developed. Normally for single core cable earthing should be done at one end of cable while other end of cable screen/armour is connected to earth through SLV (Sheath Limiter voltmeter).

The above photograph shows such failure occurred at field due to damage of outer sheath of single core cable.

Care to be taken while laying of the single core cable and after laying ensure that there is no multi earthing of screen/armour through IR meter at 500 V dc.
