# FAILURE ANALYSIS OF COMPONENTS USED FOR POWER SECTOR APPLICATIONS

Dr. Vilas Gunjal and Dr. Uday Puntambekar  
Electrical Research & Development Association (ERDA)

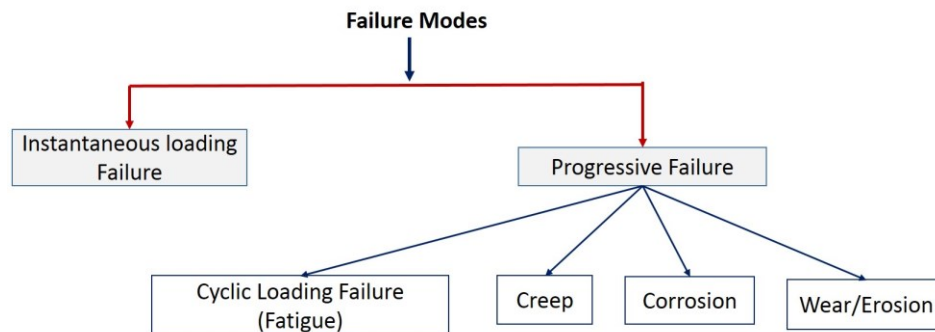
Figure 1. Various failure modes observed in engineering components

Failures are characterized either on the basis of the types of “failures modes” or the type of “service conditions” in which failures has taken place. The failure mode based characterization takes into account classical modes of material failure in different conditions, while the service condition based characterization of failures considers only the type of environment the component has experienced before failure. The failure of engineering component mostly occurs in two mode based on nature of failure: instantaneous loading failure and progressive failure as shown in Figure 1.

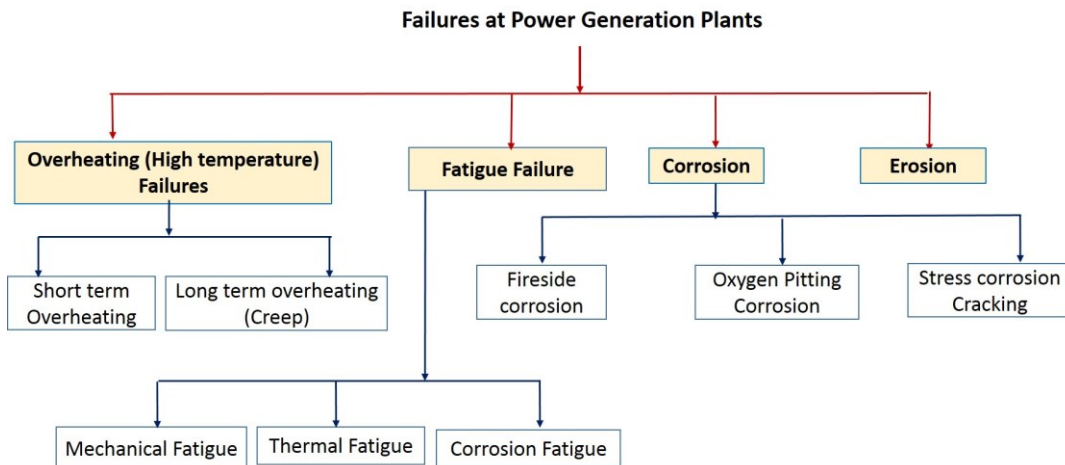
**Figure 2.** Schematic representation of failures types observed in power generation plants

Other critical components commonly found failed at power plant includes turbine blades, shafts and other structured components such as bearings, bolts and flanges etc. The major failure mechanisms responsible for the rupture of these components are creep, fatigue, erosion and corrosion. Figure 2 shows the schematic representation of component failure mechanisms observed at generation plants.

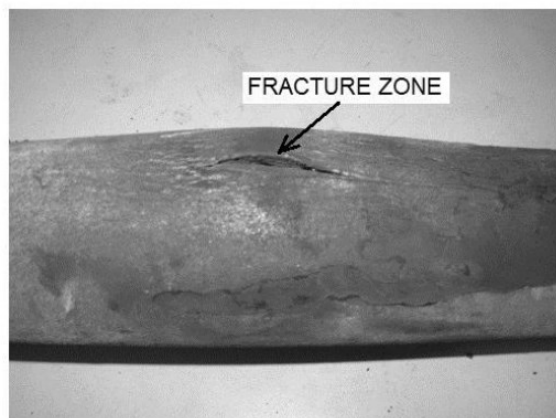
Figure 4. Boiler tube creep failure due to long term overheating [2]

Time dependent deformation of component due to prolonged exposure at higher temperature and stress is known as creep. At high temperature, softening phenomena which are controlled by diffusion phenomena such as dislocation climb, dislocation annihilations, grain boundary diffusion and sliding, structural degradation such as spheroidization, primarily dominates the deformation and rupture behavior of material. In comparison to short term overheating, creep failure (long term overheating rupture) usually takes a much longer time in the order of five to twenty years because the temperature of boiler tube is slightly above the design. Long-term overheating damage usually occur with a small amount of creep deformation and results in thick lip rupture appearance as shown in Figure 4.

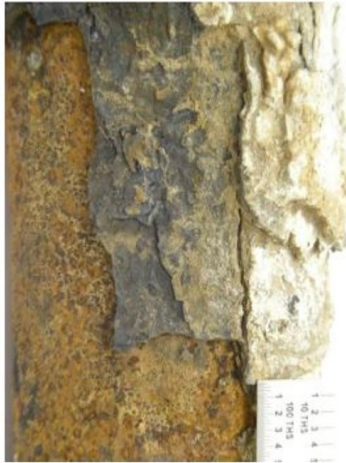
**Figure 7.** Photograph of superheater tube surface with thick deposits due to corrosion [5]

Fireside corrosion of superheater, reheater and water wall tubes is high temperature corrosion in fossil fuel combustion boilers. It is mainly caused due to presence of Sulphur, alkali metals and chlorine in the coal, oil or natural gas. During combustion of fuel sodium sulphate and oxides (such as  $V_2O_5$ ) are formed which are known as ash deposits. These low melting point deposits formed on the surface of superheater and

reheater tubes dissolve metal protective oxide layer on the fire side of a tube which is known as fire side corrosion of tube.

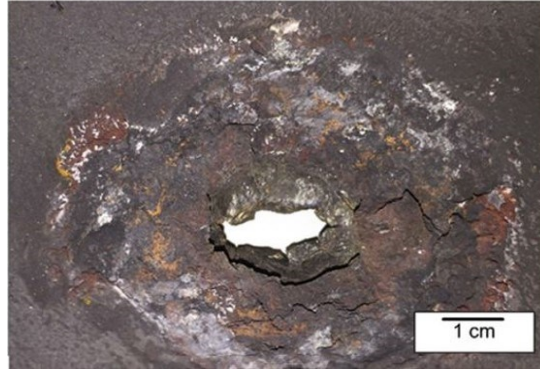
**Figure 9.** Caustic corrosion failure of tube. It shows white color deposits near the rupture [9]

The caustic corrosion of tube surface is the thinning of tube caused by caustic soda attack. It results in irregular deposit of whitish sodium carbonate (residue of caustic soda reacting with carbon dioxide in air). Solid deposits from water such as calcium and magnesium salts, silica, manganese and iron can form scale in a boiler. Under these scales, sodium salts are trapped which cause corrosion and remain unseen until you remove the scales.

The caustic treatment is commonly used to prevent failures of hydrogen damage and acid phosphate corrosion. In case of improper monitoring and control of boiler water pH, excessive amount of NaOH in boiler water can result in inevitable caustic gauging [7, 8].
