GRIDCON 2025

Online Condition monitoring technique for high voltage insulators using NL acoustic camera

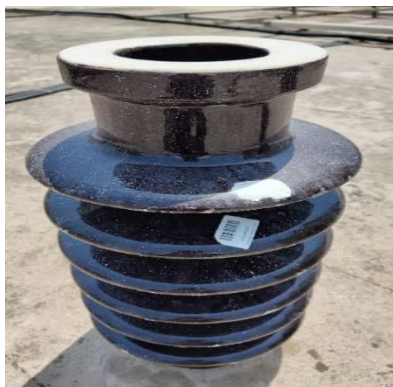
Figure 1: 33 kV Insulator Sample

Porcelain insulators of 33 kV class and 66 kV class were taken for the study as shown in Figure 1 & Figure 2 respectively. Before the measurement, these samples were thoroughly cleaned. After proper drying initial measurements were carried out on these samples before conditioning. Then these samples were conditioned in salt/fog chamber (Figure 3) with 5% NaCl salt solution [6] for 07 days for salt contamination. Measurements were conducted on these contaminated samples.
